Mill Race Inn
Building Assessment Report
August 17, 2022

Mill Race Inn

On July 20th and July 22nd, 2022, AltusWorks Inc. and our consulting engineers, Architectural Consulting Engineers and K. Eng. LLC, assessed the conditions of the existing building, building systems, structure, and accessibility in accordance with our scope of services for the Mill Race Inn, located at 4 East State Street in Geneva, Illinois.

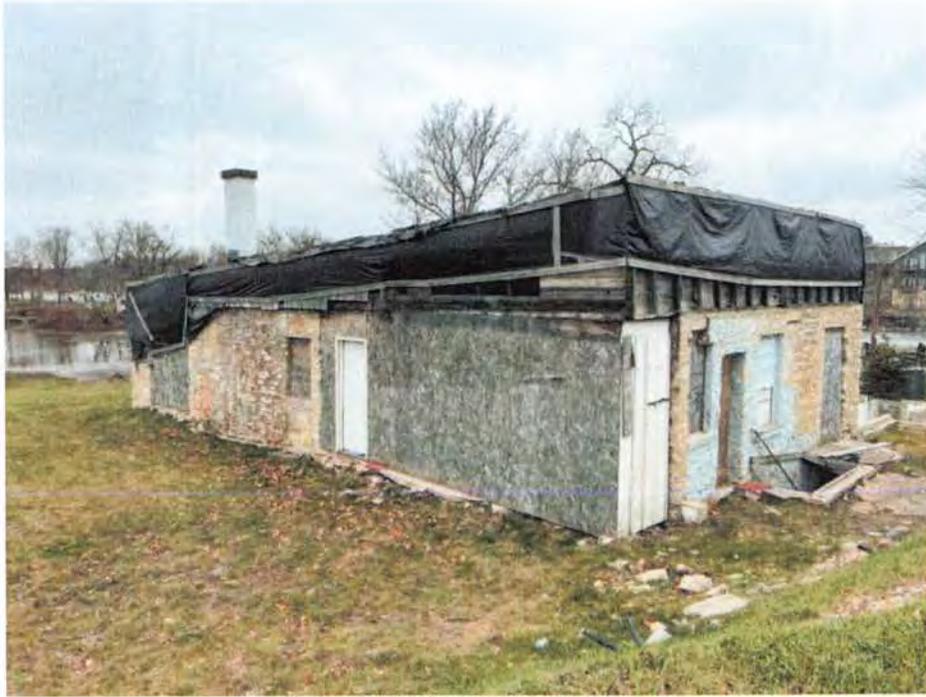
The existing one-foot-thick limestone masonry walls are one-story high configured in a rectangular plan with the long axis oriented in the north-south direction. Where the exterior limestone walls have been removed at the west and east side of the north end. Wood frame walls with plywood panels have been provided to infill the voids (Figure 1, Figure 2 and Figure 3). The southern two-thirds of the building is slab-on-grade supported by limestone foundation walls. The northern one-third of the building has a basement consisting of a combination of concrete and limestone foundation walls and basement access is via an external stair at the north end of the building (Figure 4 and Figure 5). The wood and steel beam roof structure is mono-pitch and slopes to the south (Figure 1). Two brick chimneys extend above the roof (Figure 2 and Figure 3).

Limestone (poor condition): Large sections of removed limestone have been infilled with wood framed plywood walls at the north, east and west elevations (Figure 3, Figure 1 and Figure 2). The northwest corner of the building has original stone but it is unstable.

A majority of the doors and windows at the Mill Race Inn are missing and where they are present, they are remnants likely from a former remodel (Figure 8 and Figure 11). Openings have been infilled with plywood (Figure 1, Figure 2, Figure 8 and Figure 11). The steel exterior lintels appear to be in a good condition except for a missing lintel at the window opening on the north elevation (Figure 1). The temporary door on the east elevation is the only usable entrance to the building (Figure 10).

Figure 1. North and East Elevations

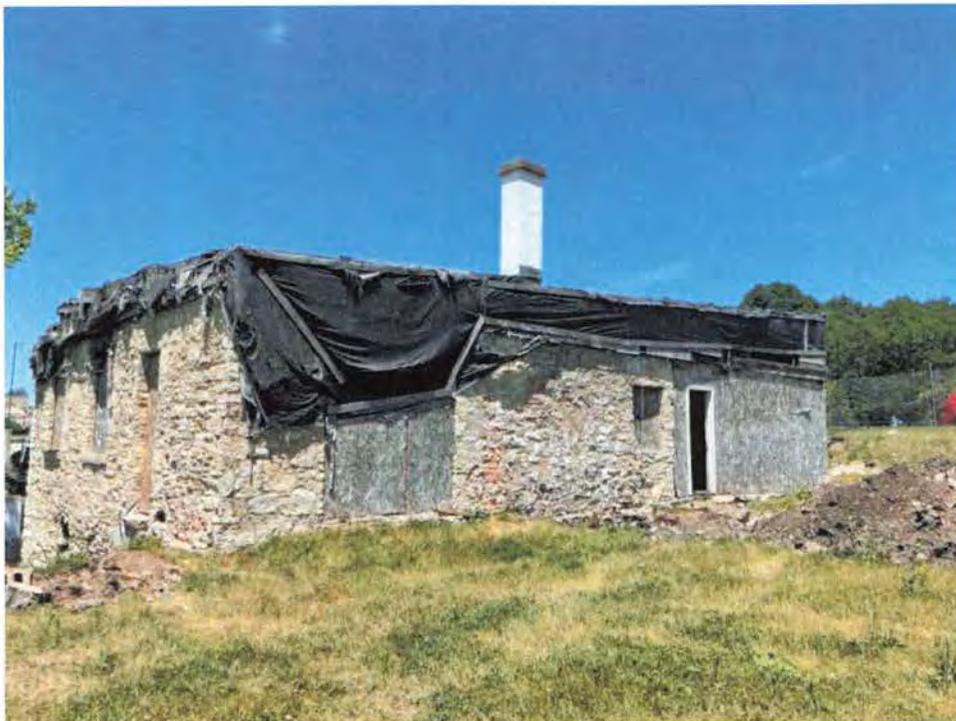
Figure 2. East and South Elevations

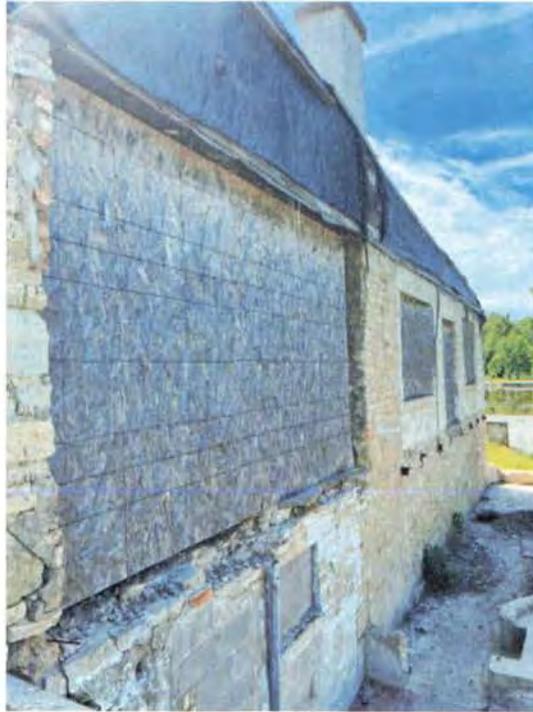
Figure 3. West facade

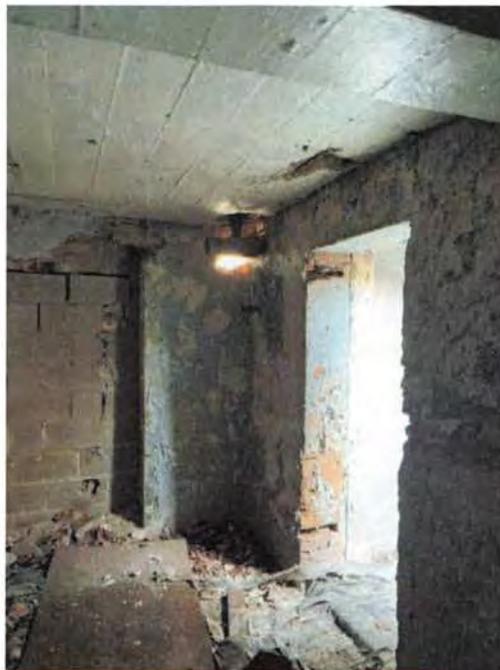
Figure 4. Existing Door opening in basement

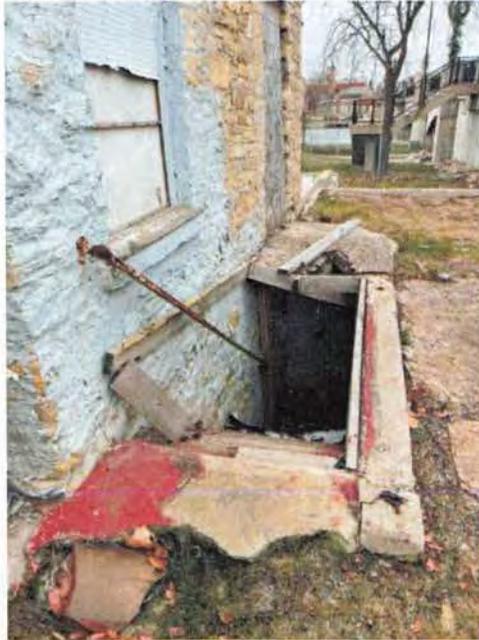
Figure 5. Stair to basement

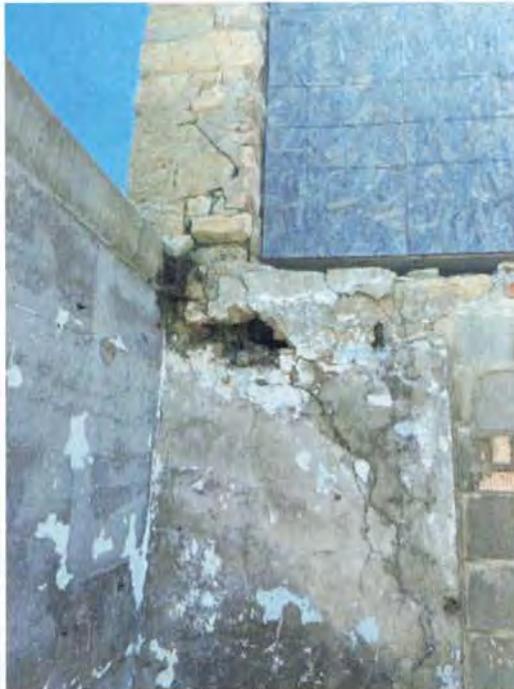
The exterior walls consist of primarily of limestone construction with some common brick used at the interior face of the north wall. Wood framed walls run along the perimeter to support the sloping roof. The limestone walls have areas that exhibit severely deteriorated (poor condition) or missing limestone (Figure 6).

Figure 6. West Elevation - basement rebuild

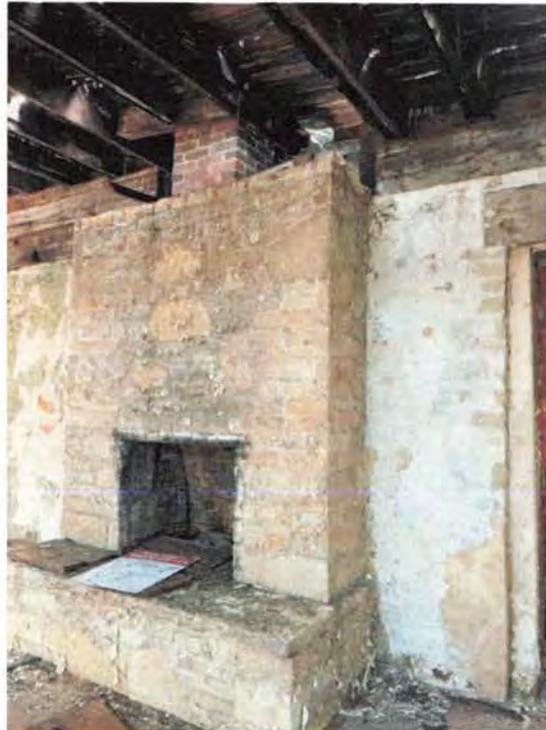
Figure 7. Existing fireplace and peeling paint

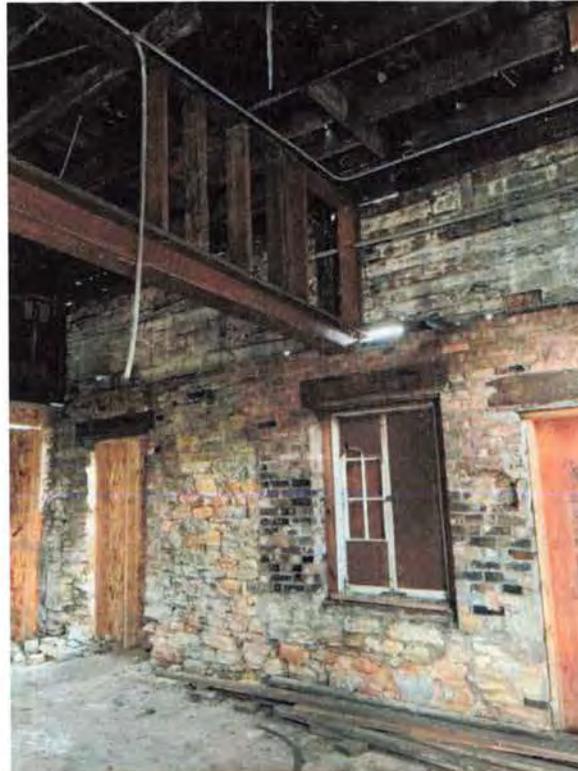
The existing wood frame is a shed roof, sloping down from north to south, is a dilapidating structure in poor condition (Figure 8, Figure 9 and Figure 10). The roof is covered by a tarpaulin as an attempt to keep the elements out (Figure 1 and Figure 2). The framing consists of wood plank decking supported by 2x8 joists spaced at 20" on center spanning east-west. The roof joists are supported by varying height wood frame walls placed over the perimeter masonry walls and over steel beams running north-south along the center of the building. The steel beams are supported by a steel interior column and by the exterior walls. An undocumented fire has partially damaged some joists and decking (Figure 11). There are brick chimneys at the east and west facades that are in fair condition. Refer to "Interior" and "Building Systems" sections for further information.

Figure 8. Interior looking northwest

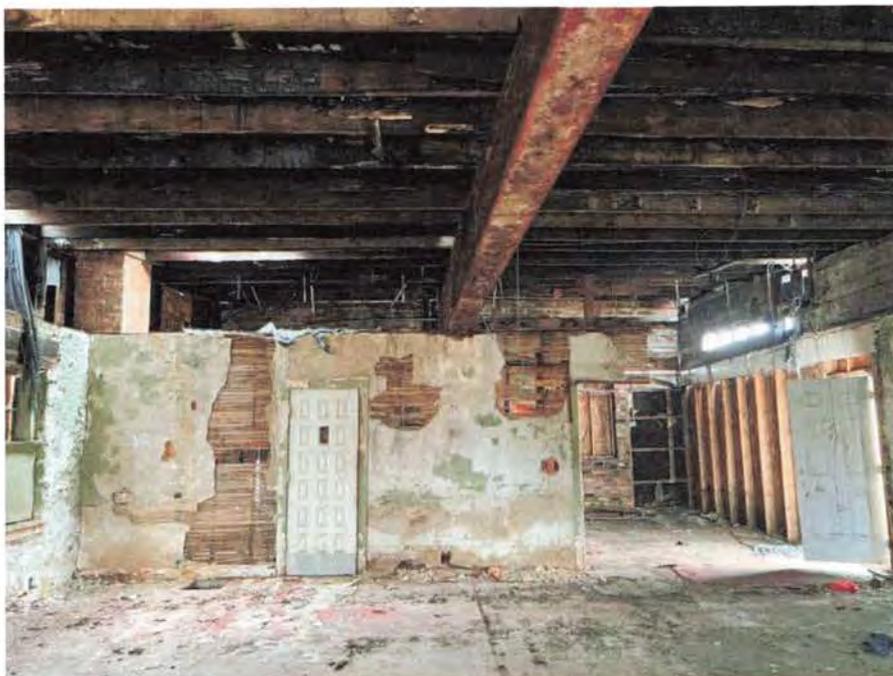
The interior partition wall and doors is in a poor condition with missing lath and areas of

missing plaster. The east portion of the interior wall is missing in its entirety. (Figure 9)

Figure 9. Interior Wall

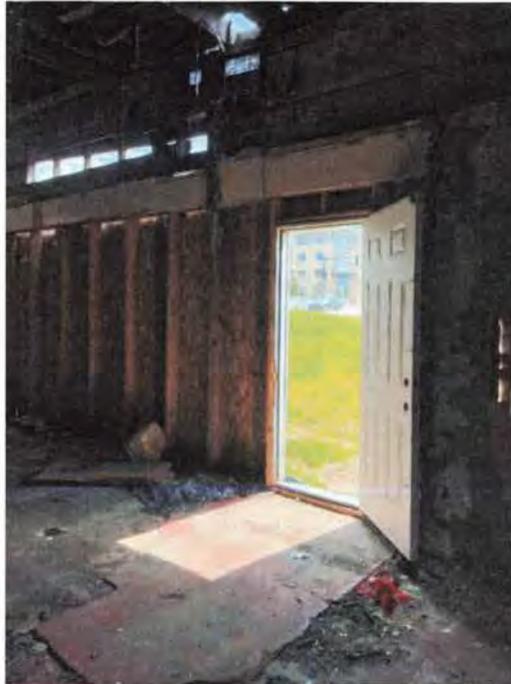
The existing floor consists of a concrete slab-on-grade over the southern two-thirds of the building while the northern one-third is a structural slab over the basement (Figure 10 and Figure 11). There are multiple penetrations through the structural slab for mechanical duct work and piping. At the east door, there is a remnant of a floor leveling compound which most likely was placed over the entire slab-on-grade. Refer to the "Building Systems" section for further information.

Figure 10. Concrete slab and existing main entrance

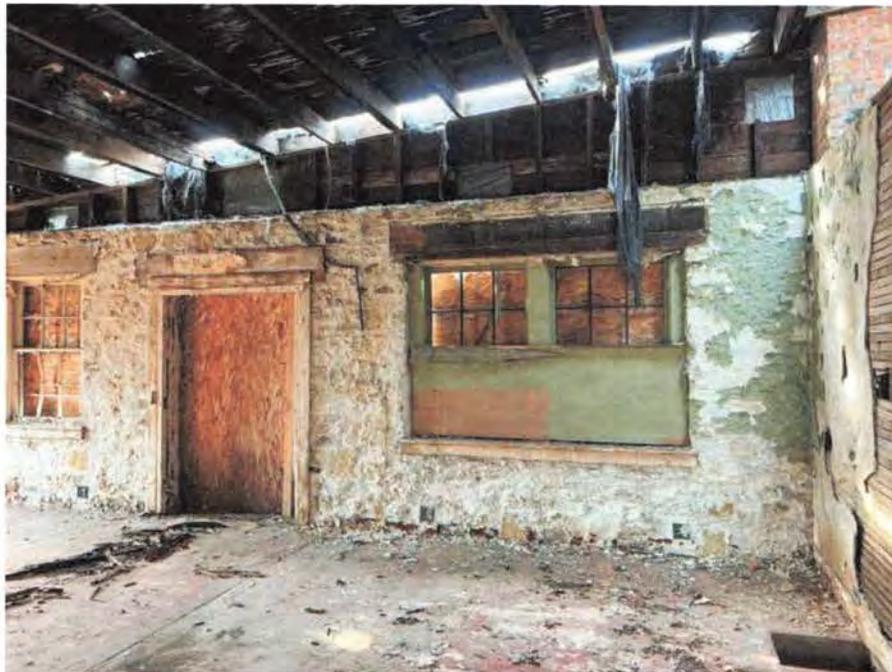
Figure 11. Interior looking west

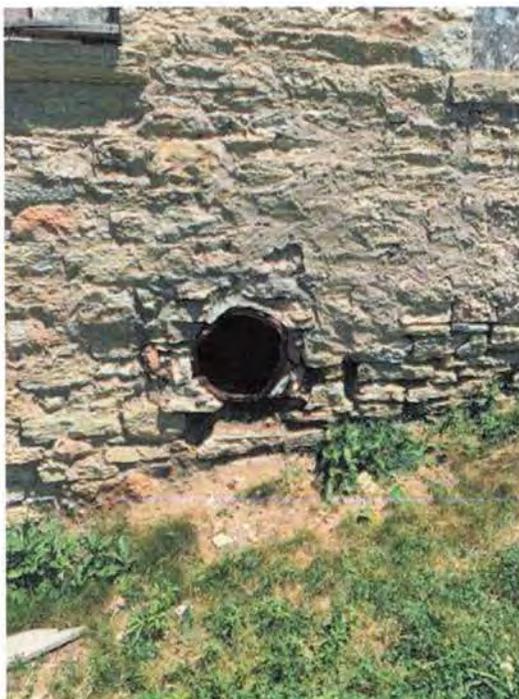
Limestone (Good to fair condition): Overall, the existing limestone is in fair condition. There are occurrences of open or cracked mortar joints, missing mortar, and individual damaged limestone pieces. In addition, some areas of the masonry walls were not properly pointed leaving mortar on the face of the limestone units (Figure 12). The exterior face of the

Figure 12. Existing masonry and mortar on limestone

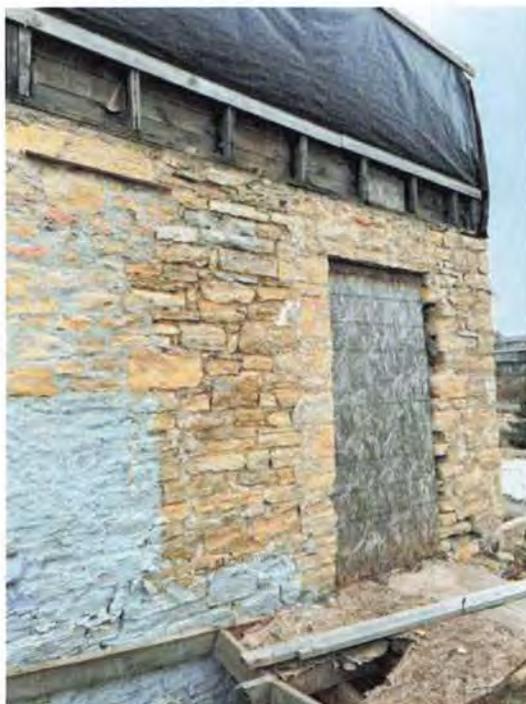
limestone on the north elevation and west elevation of the building are partially painted (Figure 13).

Figure 13. North Elevation - masonry rebuild and infill

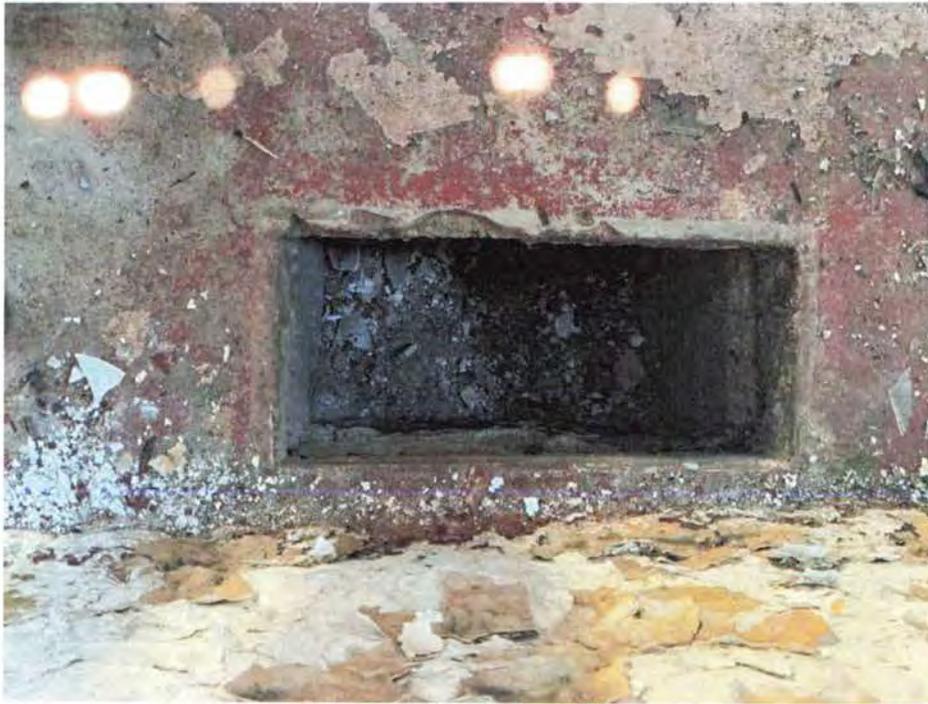
This building has no mechanical systems installed at this time. There are some artifacts from the previous system like a couple of floor grille openings (Figure 14) on the south side of the building that appear to be fed by a large vitreous clay duct/pipe routed through the crawlspace from the partial basement to the south exterior wall (Figure 15 and Figure 16). These remaining abandoned system components should be demolished unless there is a desire to use the underfloor duct/pipe to route other utilities from the back of the building to the partial basement.

Figure 14. Floor Return Grille

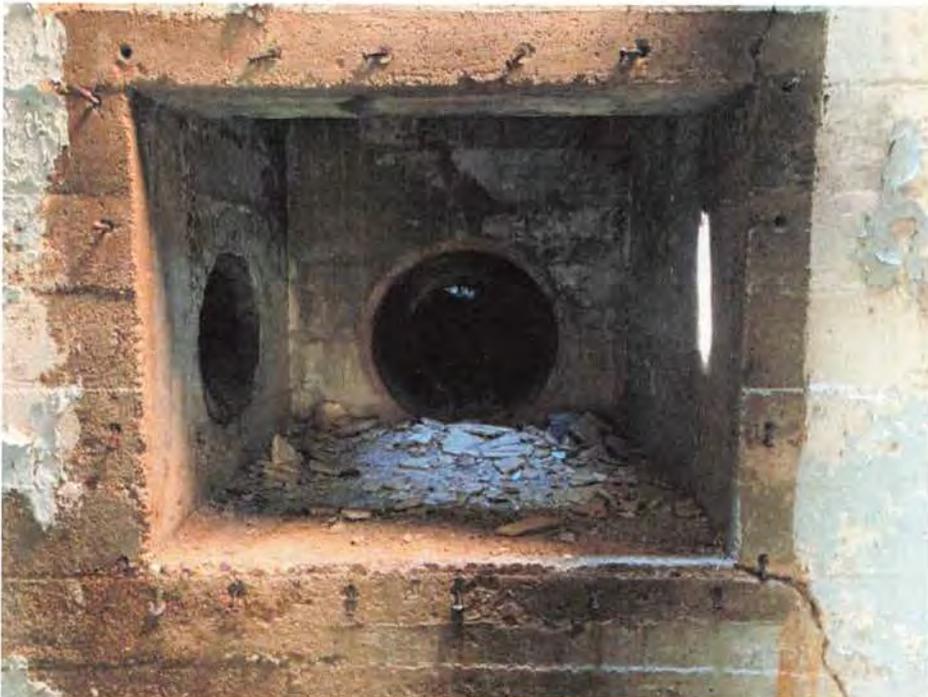
Figure 15. Abandoned Duct/Pipes at Basement Wall

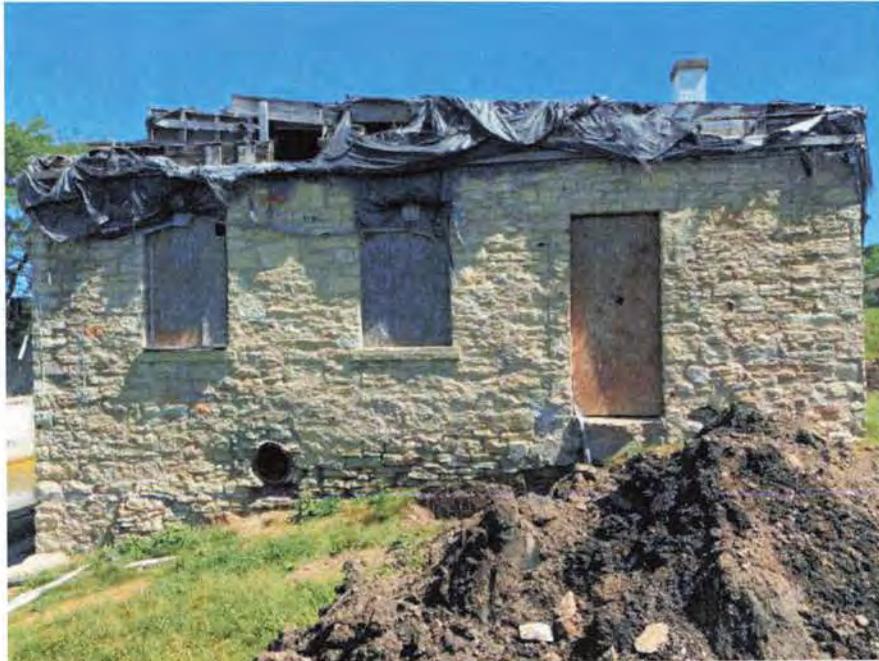
Figure 16. Duct/Pipe Opening at South Exterior Wall

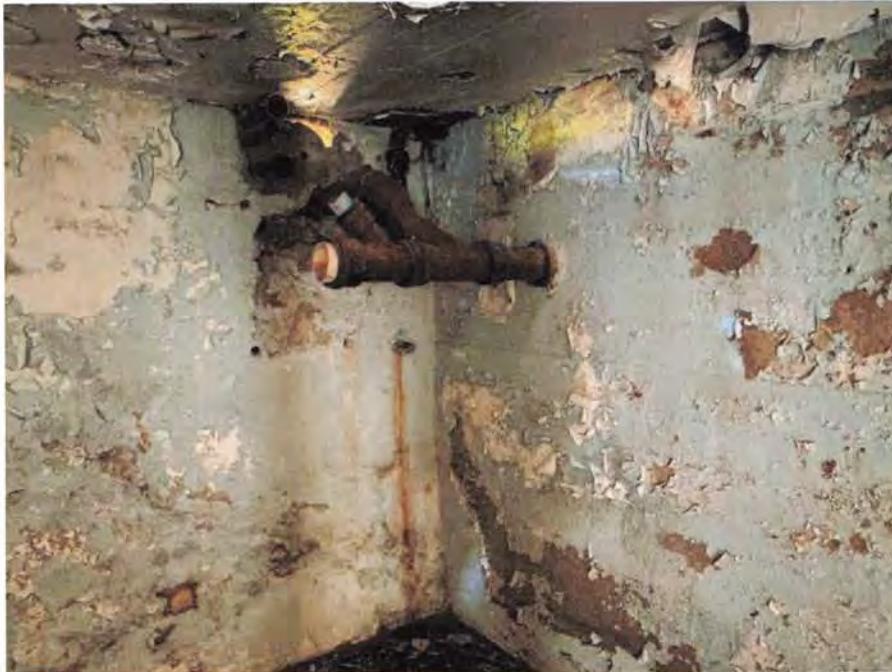
Figure 17. Waste Pipe Out Basement Wall and Assumed Domestic Water Directly Below.

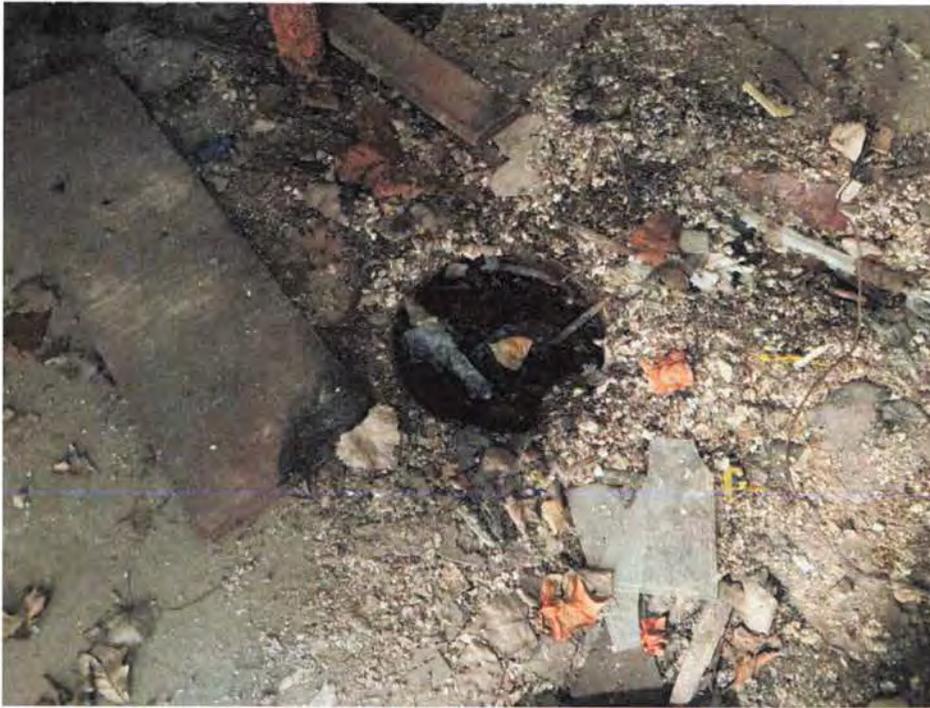
Figure 18. Small Sump Pit in Basement Floor

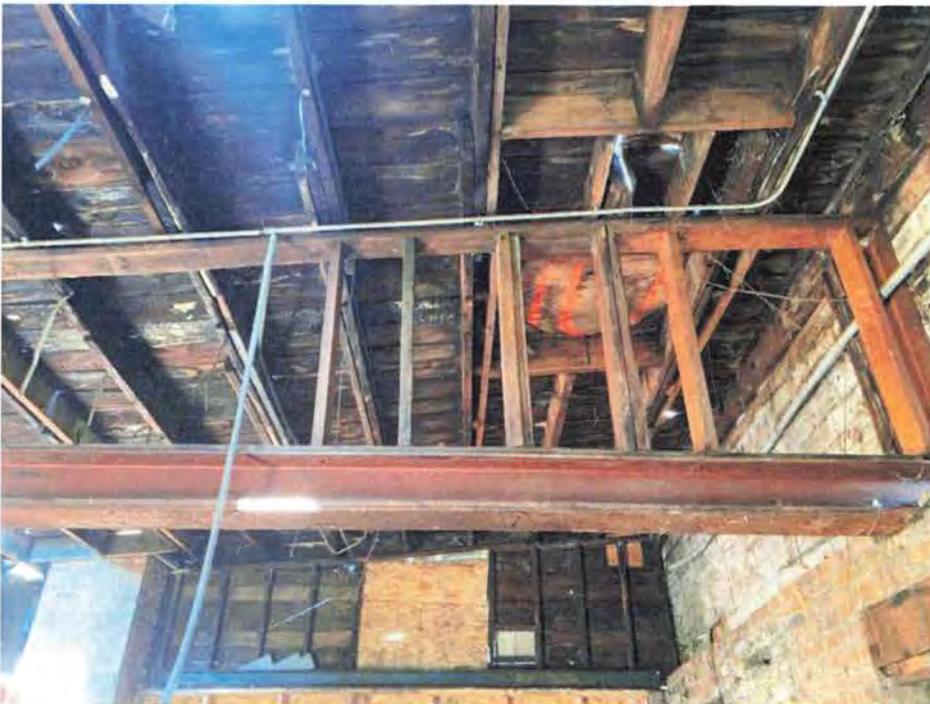
The building has no operational electrical system. There are numerous abandoned electrical components (conduit, receptacles, light fixture housings, junction/pull boxes, etc.) but there is no electric service to the building, distribution panels, or other equipment that is operational. (Figure 19, Figure 20 and Figure 21)

Figure 19. Abandoned Conduit Throughout the Building

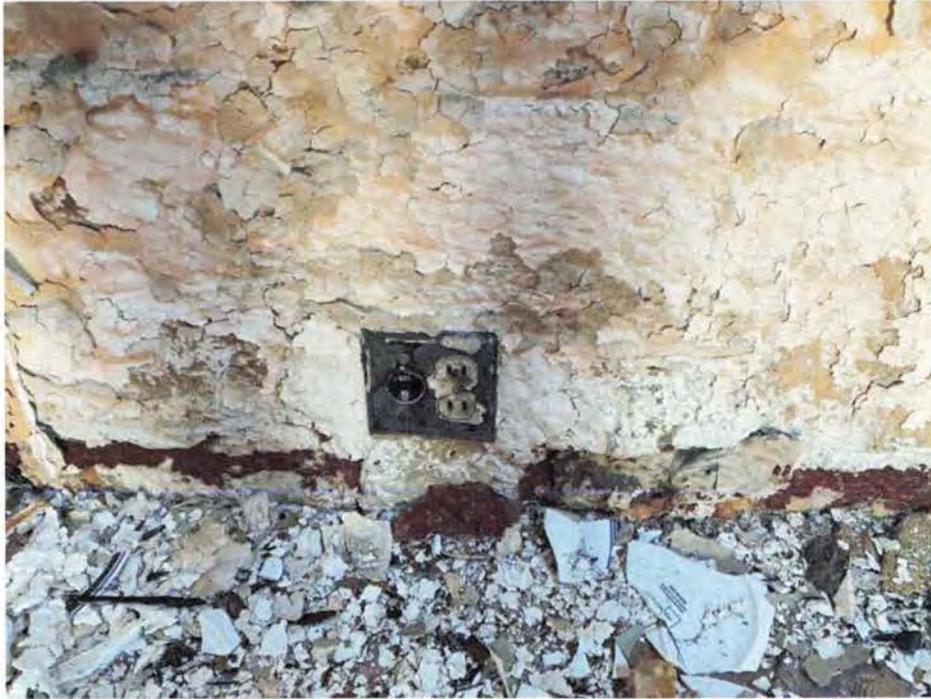
Figure 20. Abandoned and Obsolete Receptacles Throughout the Building

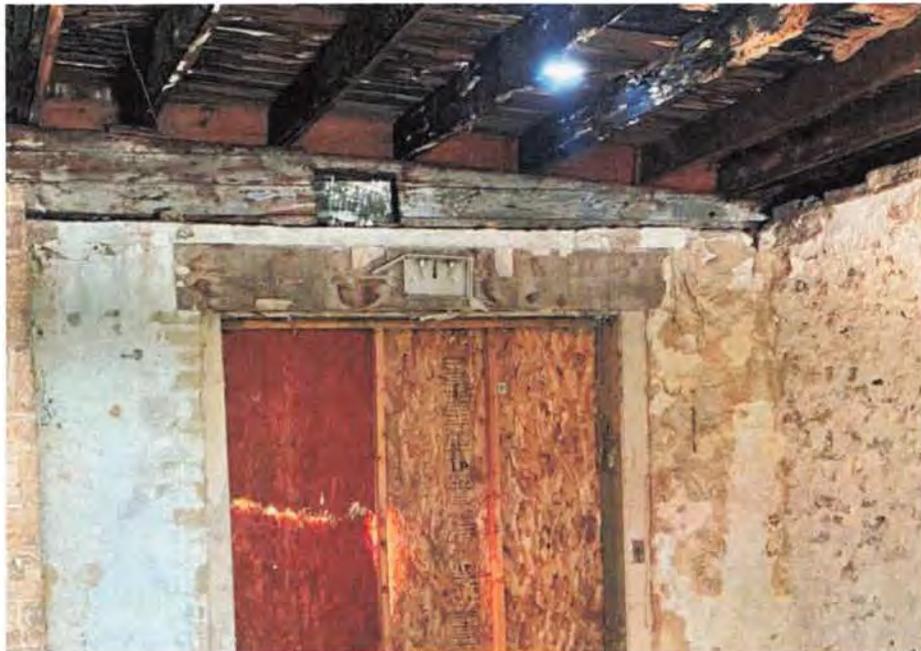
Figure 21. Abandoned Exit Light Housing
